**Flood Control Project Maintenance
Levee Inspections**

Fall 2019 Levee Maintenance Deficiency Summary Report

Reclamation District No. 0817 Carlin

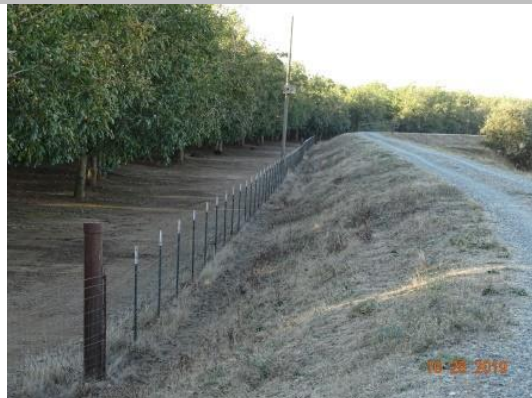
Photo 1 of 1 : FA_2019_RD0817_12_25_20191030_00016.jpg

View looking downstream landside at the well maintained annual vegetation, Fall 2019.

LM Start	0.01	Rating **	A	Issue No.	26
LM End	1.12	Issue Type +	Ma	Location *	WS
Category	Earthen Levee			GPS Latitude/Longitude	
				Start	End
Item	Vegetation			38.984859 °	38.995515 °
				-121.506056 °	-121.491157 °
DWR ID	DWR_RD0817_01_f_2019_26				
Comment Code					
V1 : Control annual grass and weeds on the levee slopes and easements.					
Inspector Comment					
The annual vegetation is well maintained, Fall 2019.

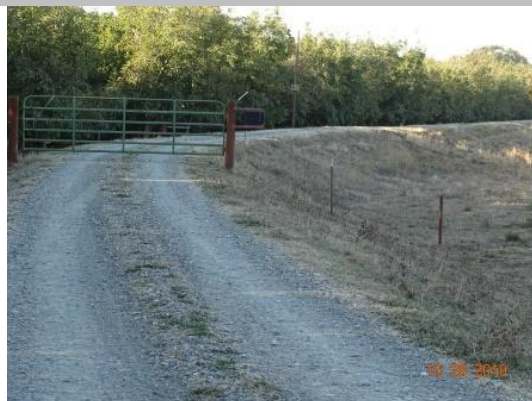
Photo 1 of 1 : FA_2019_RD0817_12_26_20191030_00017.jpg

View looking downstream waterside at the well maintained annual vegetation, Fall 2019.

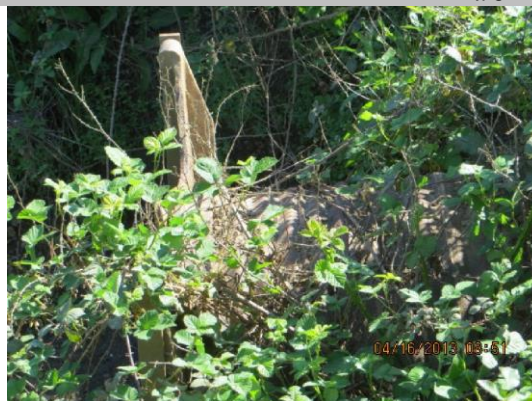
Photo 2 of 3 : UCIP_FA_2019_54440_19864.jpg

WS- CM pipe and flap gate

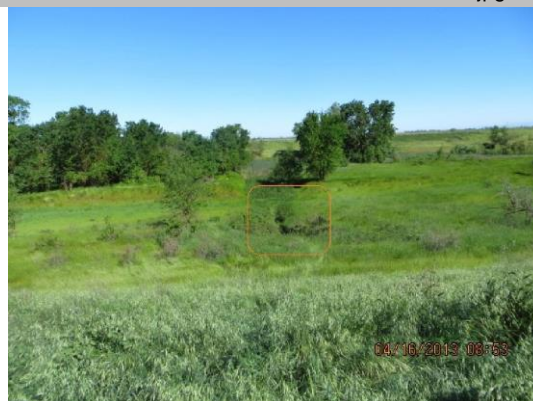
Photo 3 of 3 : UCIP_FA_2019_54440_19863.jpg

Comment Code						
Inspector Comment						
DS_ID:18985 FS_ID:54440 EP_NO: N/A Repair Type: Non-Urgent Crossing Status: Found UCIP Comments: 08/14/2019 DMP Internal Inspection Report shows minor defects in the pipe through the levee. This pipe is considered Non-Urgent: Low Priority. District Engineer, Tom Engler, recommends lining or removing/replacing pipe. The pipe is a critical pipe for the District since it handles a large portion of the drainage into Dry Creek. The pipe is responsible for draining most of the Wheatland basin into Dry Creek. Mr. Tom Engler recommends replacing the pipe to current standards including adding positive closure device on both sides of the levee so that the District has a backup if/when the flap gate located on the WS eventually fails. Supporting documentation submitted by the District Engineer has been forwarded to DMP. (O. Magana - DWR UCIP) 04/16/2013 Dense vegetation on waterward and landward slopes limit visual inspection of potential leaks along pipe alignment. Recommend having owner clear vegetation along slopes. (P. Amatya - DWR UCIP) FIELD_STRUCT_DESC: 48-inch corrugated metal gravity drainage pipe through the levee, 23.3 feet below the crown. Flap gate on the waterside (WS) end. [Additional Reference(s): DWR Levee Log, 2005. USACE Sacramento O&M Manual 146, November 1962, (HLM 0.28)]. FS Date: 4/16/2013

WS- dense vegetation on WS of the levee

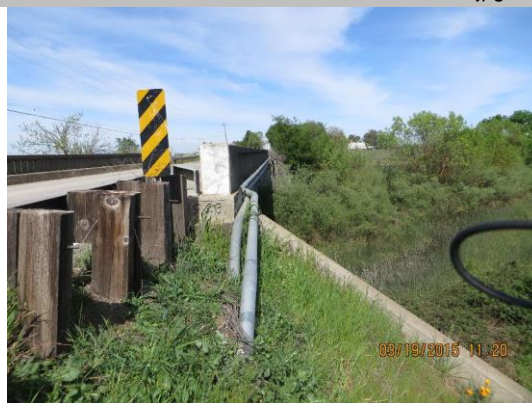
Photo 1 of 2 : UCIP_FA_2019_44084_73565.jpg

LM Start	1.13	Rating **	M	Issue No.	33
LM End	1.13	Issue Type +	En	Location *	
Category	Supplemental			GPS Latitude/Longitude	
				Start	End
Item	DRAFT DWR UCIP Field Study			38.995667 °	38.995667 °
				-121.490981 °	-121.490981 °
DWR ID	25088				
Comment Code					
Inspector Comment					
DS_ID:25088 FS_ID:44084 EP_NO: N/A Repair Type: Non-Urgent Crossing Status: Found UCIP Comments: 03/19/2015 No permit identified for this crossing. (P. Amatya - DWR UCIP) FIELD_STRUCT_DESC: *DUPLICATE--DELETE ENTRY* 4-inch steel telephone conduit through the levee, 4 feet below the crown. FS Date: 3/19/2015

Communication conduit visible on upstream side of bridge.

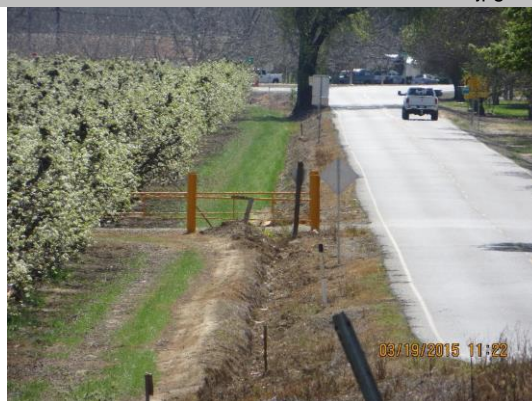
Photo 2 of 2 : UCIP_FA_2019_44084_73564.jpg

LM Start	1.13	Rating **	M	Issue No.	33 (cont)
LM End	1.13	Issue Type +	En	Location *	
Category	Supplemental			GPS Latitude/Longitude	
				Start	End
Item	DRAFT DWR UCIP Field Study			38.995667 °	38.995667 °
				-121.490981 °	-121.490981 °
DWR ID	25088				
Comment Code					
Inspector Comment					
DS_ID:25088 FS_ID:44084 EP_NO: N/A Repair Type: Non-Urgent Crossing Status: Found UCIP Comments: 03/19/2015 No permit identified for this crossing. (P. Amatya - DWR UCIP) FIELD_STRUCT_DESC: *DUPLICATE--DELETE ENTRY* 4-inch steel telephone conduit through the levee, 4 feet below the crown. FS Date: 3/19/2015

Fiberoptic line markers along roadway to south of bridge.

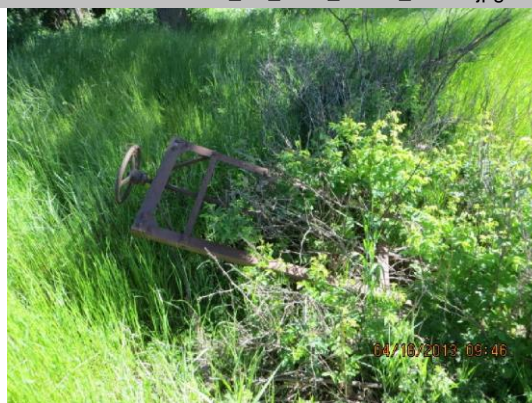
Photo 2 of 3 : UCIP_FA_2019_54435_19881.jpg

WS- closer look at damaged slide gate on WS

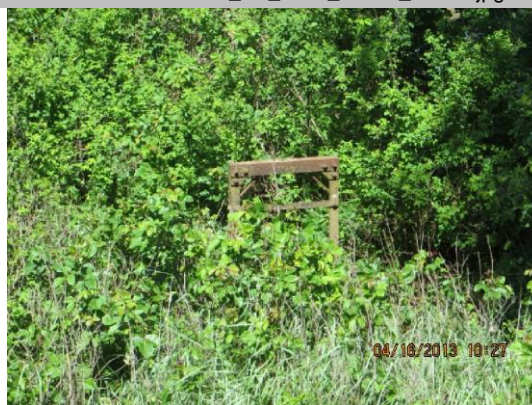
Photo 2 of 3 : UCIP_FA_2019_54436_19891.jpg

WS- slide gate

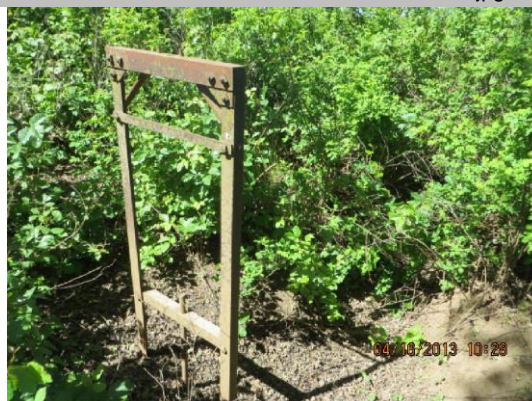
Photo 3 of 3 : UCIP_FA_2019_54436_19890.jpg

Comment Code						
Inspector Comment						
DS_ID:18988 FS_ID:54436 EP_NO: N/A Repair Type: Non-Urgent Crossing Status: Found UCIP Comments: 08/14/2019 No DMP Internal Inspection Report was completed for this pipe. Pipe was either completely buried or access to inlet/outlet was not feasible. Pipe has been abandoned and no longer needed per LMA District Engineer, Tom Engler. District Engineer recommends removal of this pipe. Supporting documentation submitted by the District Engineer has been forwarded to DMP. (O. Magana - DWR UCIP)04/16/2013 A burried slide gate on WS of the levee. Need to contact owner to determine status of crossing. If crossing is no longer in use owner will need to contact CVFPB to comply with Title 23. Dense vegetation on waterward and landward slopes limit visual inspection of potential leaks along pipe alignment. Recommend having owner clear vegetation along slopes. (P. Amatya - DWR UCIP) FIELD_STRUCT_DESC: *ABANDONED* 18-inch corrugated metal gravity drainage pipe through the levee, 13.8 feet below the crown. Slide gate on the waterside (WS) end. [Additional Reference(s): DWR Levee Log, 2005. USACE Sacramento O&M Manual 146, November 1962, (HLM 1.62)]. FS Date: 4/16/2013

WS- buried slide gate

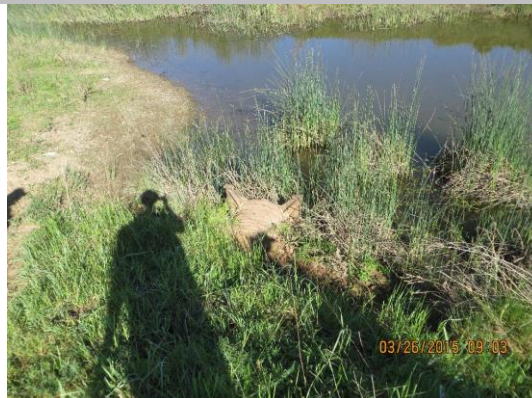
Photo 1 of 3 : UCIP_FA_2019_54438_73422.jpg

Pipe and flapgate visible on WS toe.

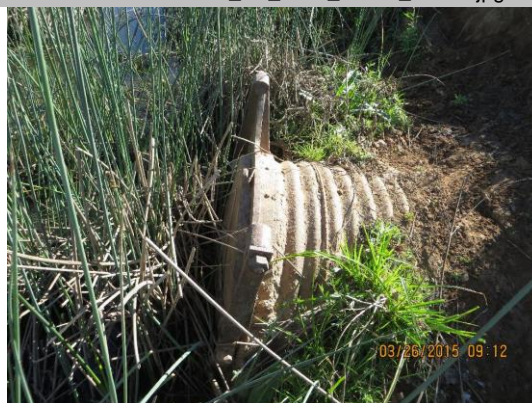
Photo 2 of 3 : UCIP_FA_2019_54438_73421.jpg

Pipe and flapgate visible on WS toe.

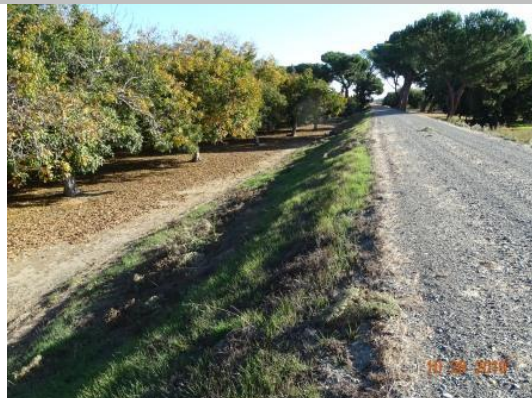
Photo 1 of 1 : FA_2019_RD0817_13_9_20191030_00024.jpg

View looking upstream landside at the well maintained annual vegetation, Fall 2019.

LM Start	0.00	Rating **	A	Issue No.	10
LM End	3.25	Issue Type +	Ma	Location *	WS
Category	Earthen Levee			GPS Latitude/Longitude	
				Start	End
Item	Vegetation			38.984722 °	38.993891 °
				-121.506112 °	-121.448154 °
DWR ID	DWR_RD0817_02_f_2019_10				
Comment Code					
V1 : Control annual grass and weeds on the levee slopes and easements.					
Inspector Comment					
The annual vegetation is well maintained, Fall 2019.

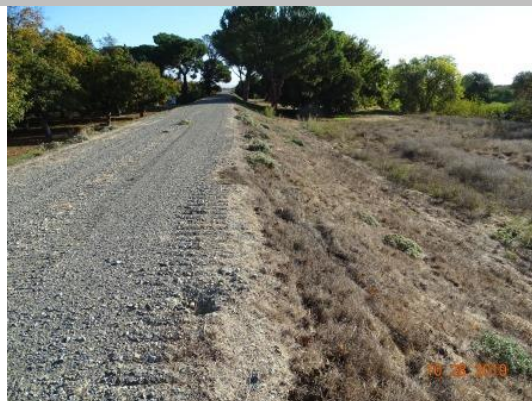
Photo 1 of 1 : FA_2019_RD0817_13_10_20191030_00025.jpg

View looking upstream waterside at the well maintained annual vegetation, Fall 2019.

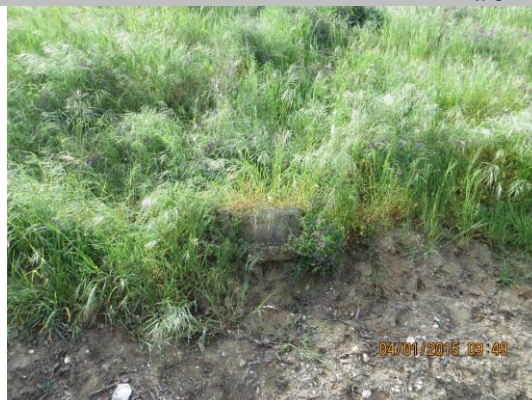
Photo 2 of 3 : UCIP_FA_2019_54439_73541.jpg

Concrete standpipe visible on lower slope of LS toe.

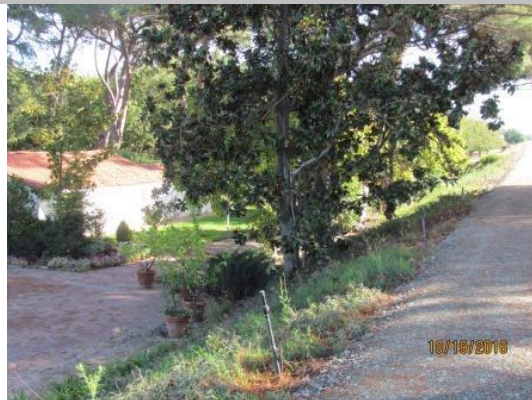
Photo 1 of 1 : FA_2019_RD0817_13_2_20190904_00001.jpg

View of the homeowners landscape vegetation on the landside levee slope, looking upstream.

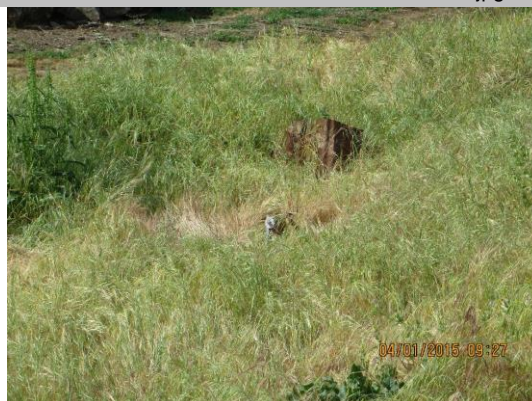
Photo 3 of 3 : UCIP_FA_2019_46182_74561.jpg

Pipe and hose bib visible in tall grass at WS toe.

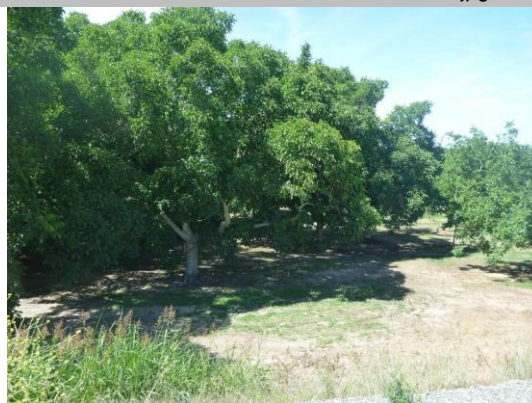
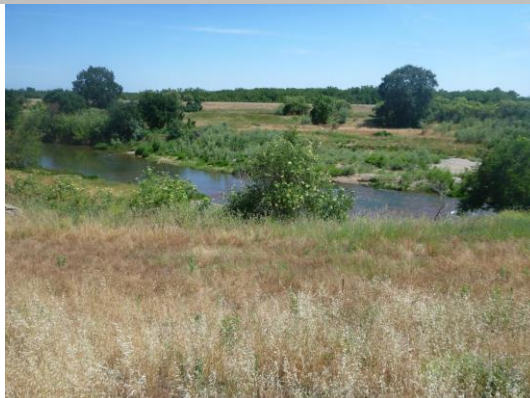
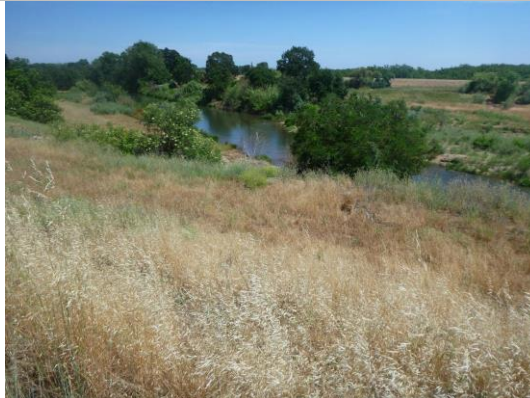
LM Start	2.08	Rating **	A/W	Issue No.	13	
LM End	3.18	Issue Type +	Ma	Location *		
Category	Supplemental			GPS Latitude/Longitude		
				Start	End	
Item	2017 Storm Damage			38.989338	°	38.994124
				-121.468640	°	-121.449448
DWR ID	DWR_RD0817_02_s_2012_10					
Comment Code						
Inspector Comment						
Levee Evaluation Comments						
Description:						
Site ID No:162						
Site Designation:DWR_RD0817_02_s_2012_10						
Repair Type: Stability						
Rating:Area of Concern						
Field Date:6/5/2017						
Notes: Stability issues are due to levee geometry. Narrow steep slopes.

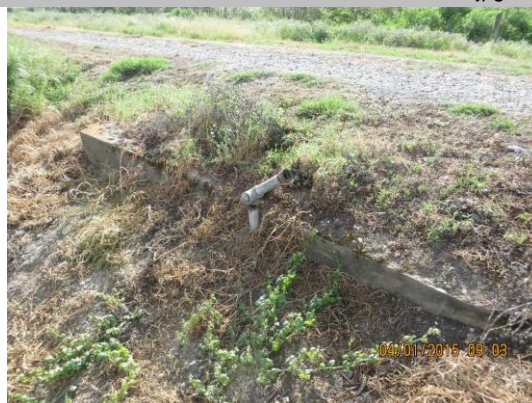
Photo 3 of 3 : UCIP_FA_2019_44105_73584.jpg

Pipe and concrete headwall visible on LS shoulder.

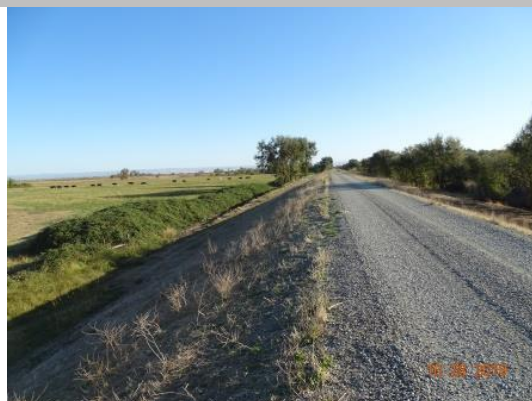
Photo 1 of 1 : FA_2019_RD0817_14_8_20191030_00023.jpg

View looking upstream landside at the well maintained annual vegetation, Fall 2019.

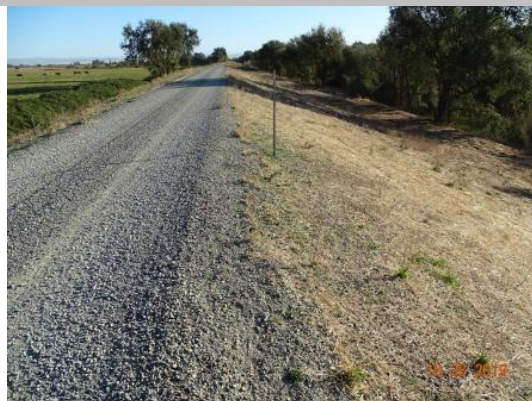
Photo 1 of 1 : FA_2019_RD0817_14_9_20191030_00024.jpg

View looking upstream waterside at the well maintained annual vegetation, Fall 2019.

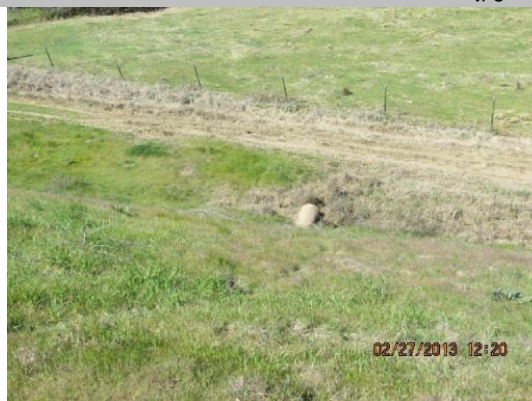
Photo 1 of 3 : UCIP_FA_2019_54258_54271.jpg

Pipe at LS toe

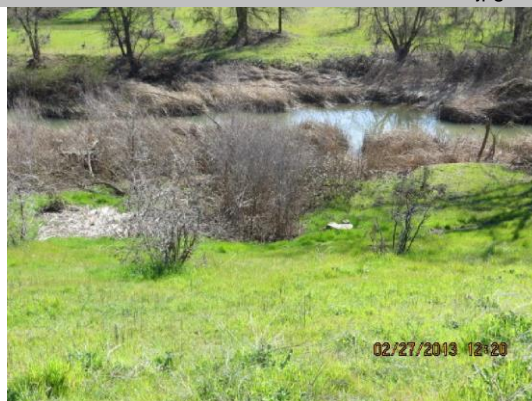
Photo 2 of 3 : UCIP_FA_2019_54258_54270.jpg

Outlet in brush at WS toe.

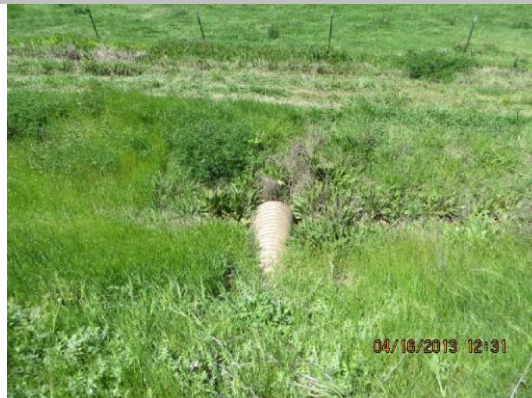
Photo 1 of 3 : UCIP_FA_2019_42686_19927.jpg

LS- overview of CM drainage pipe on toe of the levee.

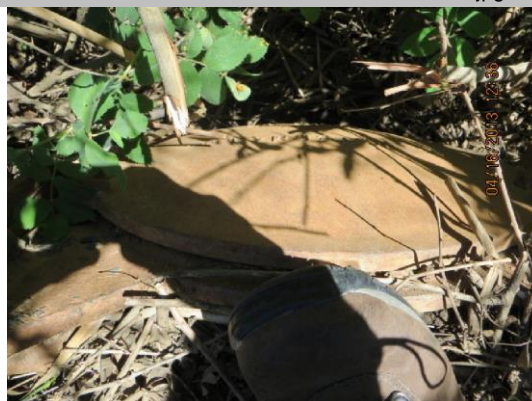
Photo 3 of 3 : UCIP_FA_2019_42686_19928.jpg

WS- flap gate on CMP end on levee toe.

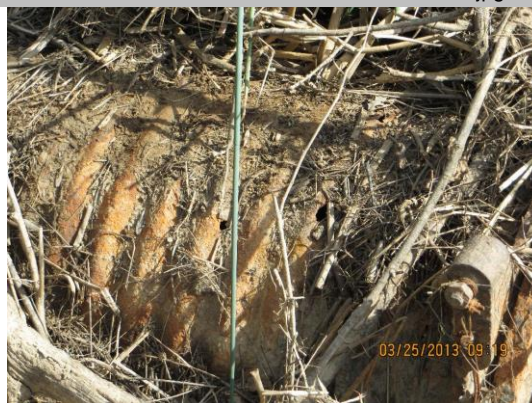
Photo 2 of 3 : UCIP_FA_2019_54257_53853.jpg

Holes in pipe at broken flapgate on WS toe.

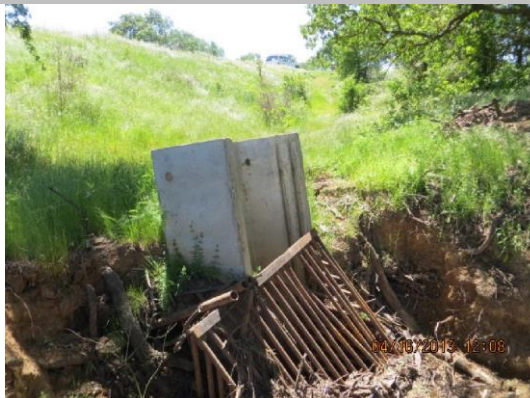
Photo 3 of 3 : UCIP_FA_2019_41163_19940.jpg

LS- half box concrete outlet structure with trash rack.

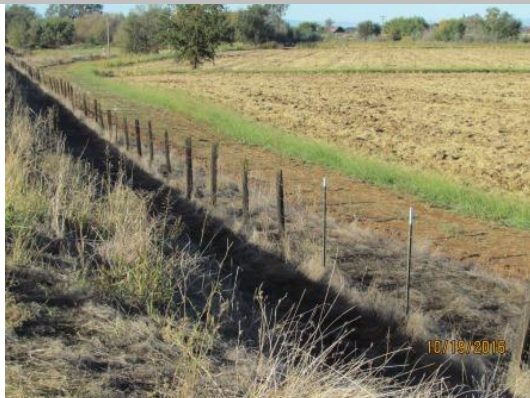
Photo 1 of 1 : FA_2019_RD0817_14_15_20190904_00001.jpg

View of fence at landside toe looking downstream.

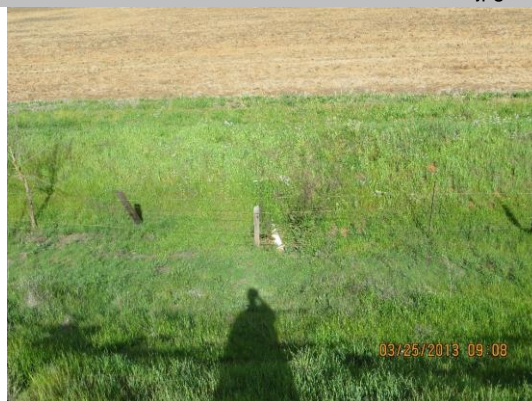
Photo 1 of 3 : UCIP_FA_2019_54266_53857.jpg

Pipe on LS toe with 8-inch PVC pipe sticking out.
